Extended Reliability Performance Test

SEPTEMBER 2016

Lexmark CX860dte

with Multi-position Staple Hole Punch Finisher

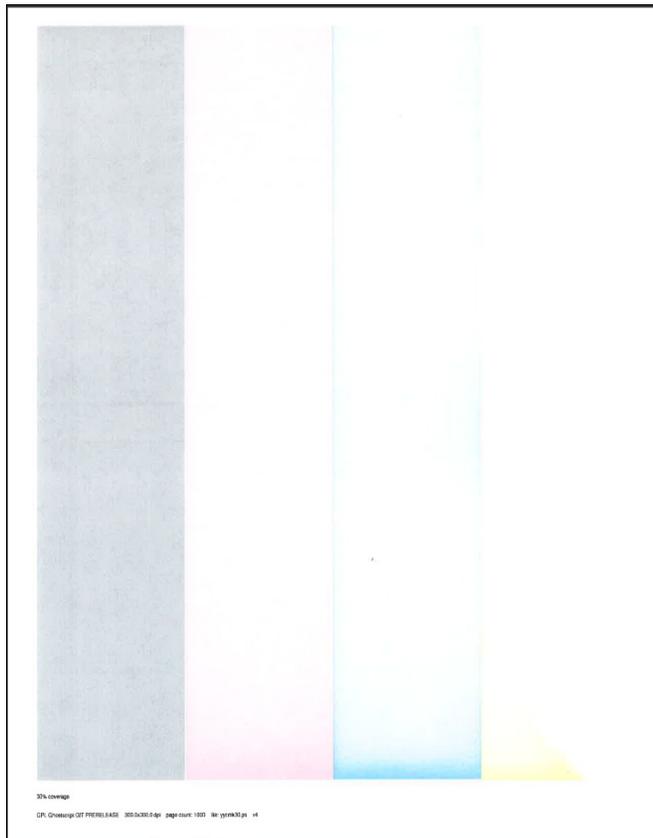
2. According to Lexmark engineers, the root cause of this issue was a plastic part used to tension the belt that was made just below the allowable tolerances. This part is only used in aftermarket image transfer units (ITUs). By being out of spec, the part failed to tension the ITU correctly, causing the print quality defect. As a result of this discovery, the parts have been reviewed and manufacturing process changes are in place to ensure this part is made to specifications in all future production.

At meter count 622,027 impressions into testing on the CX860dte, BLI technicians replaced the Image Transfer Unit, which had reached end of life. Shortly thereafter, at meter count 641,623, BLI technicians noted that toner was not being properly transferred to pages. The page shown above should contain four solid bars of black, magenta, cyan and yellow. BLI technicians installed a replacement transfer unit and the issue was resolved.

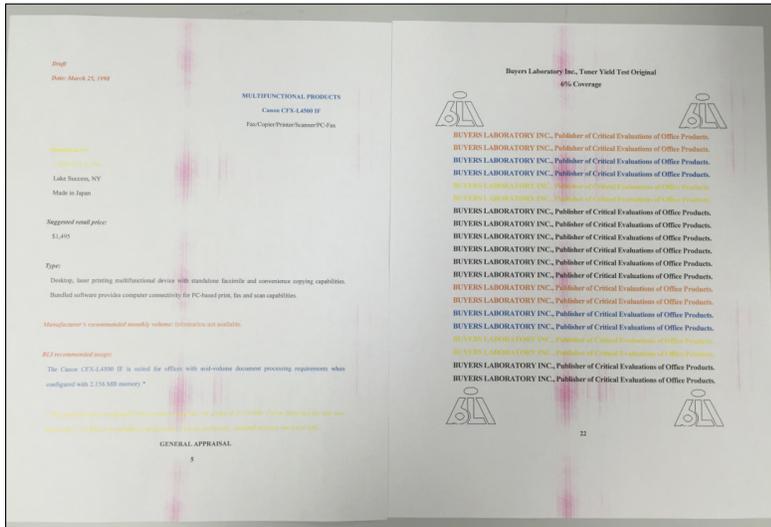
At meter count 799,128 impressions into testing, BLI technicians noted streaking on output.

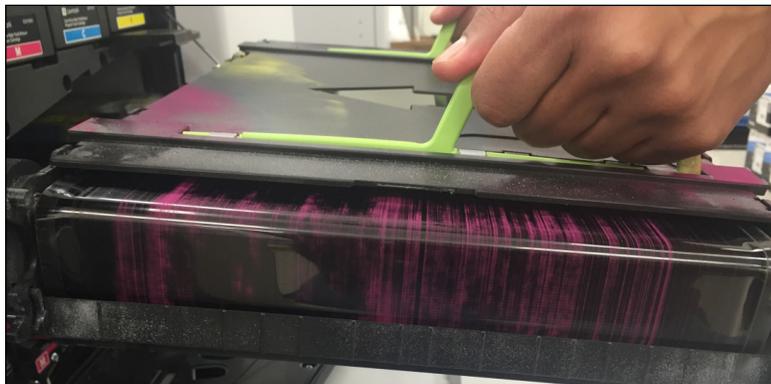
Technicians noted that the transfer unit was contaminated with magenta toner.

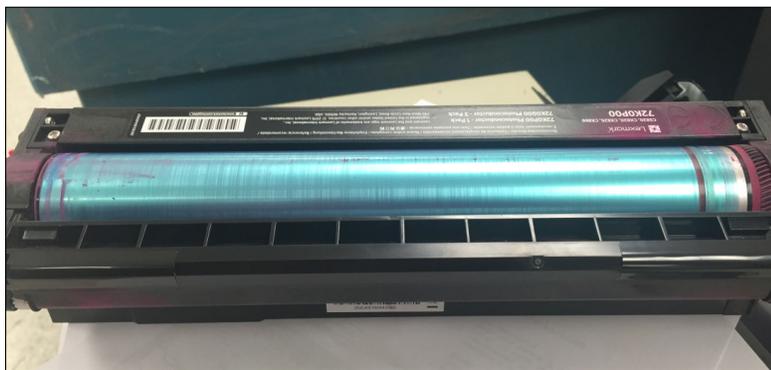
3. According to Lexmark engineers, this early life photoconductor failure has been well researched and was caused by a lower than expected force internal to the photoconductor. This issue has been remedied in more recent production by a force optimization and is not expected to occur in future components.

At meter count 799,128 impressions into testing, BLI technicians noted streaking on output. Upon further investigation, technicians noted that the magenta drum unit was defective. Replacing it with a new unit resolved the issue.
